# MODULAR SHOOT HOUSE MSH

Featuring Thermal Shot™ Detection with Virtual Targetry

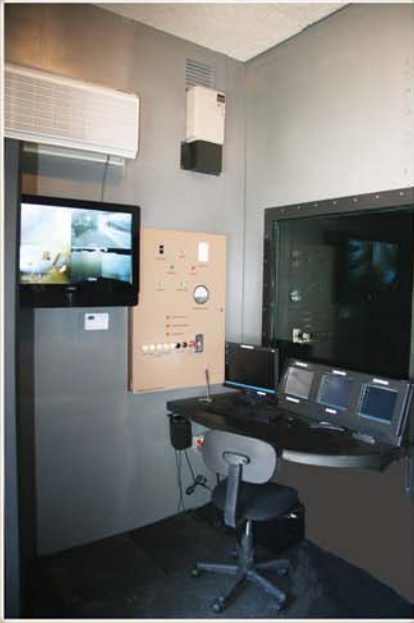
# MSH

### Base Specifications:

- Base rifle-rated MSH with dimensions of 40' deep x 24' wide
- The MSH is configured on 40' long x 8' wide modules

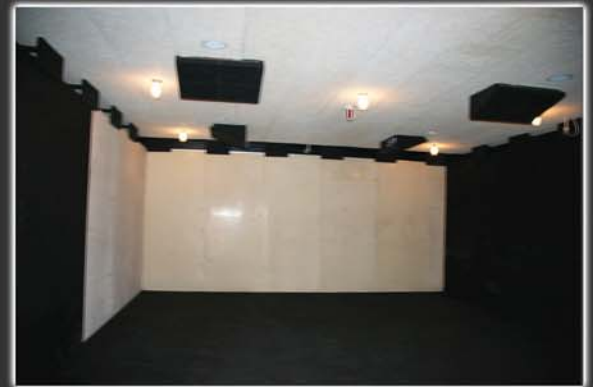
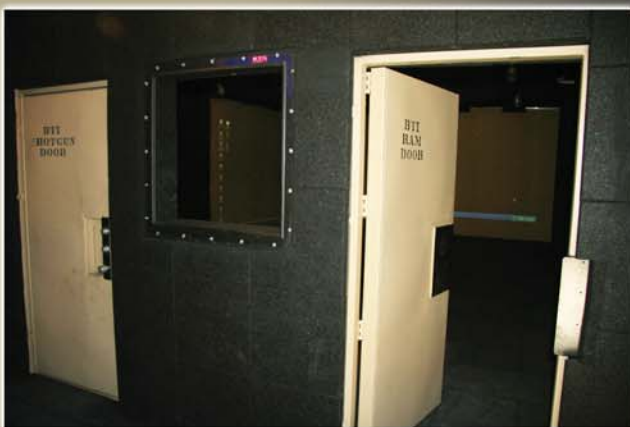
### Live-Fire Shooting Area:

- Ceiling and walls are constructed armor plating that is AR500 Certified
- 2" Ballistic rubber floor tiles
- Full safety ceiling with 8" Acoustical Wool and 1" Sound attenuating board
- 4 Ballistic Shrouds containing the Laser Shot Live-Fire Detection Camera and projection systems.
- 4 Self-Sealing Live-Fire Screens
- 1 CCTV video camera

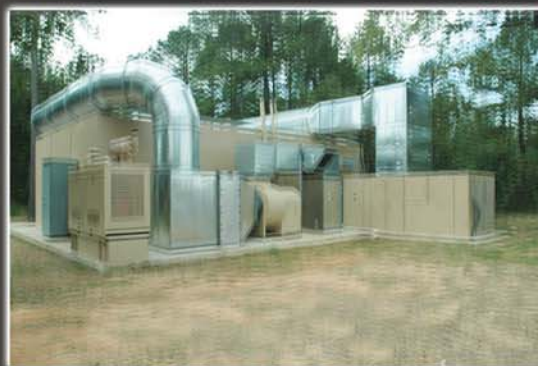
### HVAC, NIOSH, OSHA and EPA Compliant Certified:

- 99.99% HEPA Filter HVAC System with (2) 30% pre-filter banks
- Electrical distribution panels with utility power connector
- Filter condition gauge
- Power exhausted blower(s)
- Duct heater(s) with controls
